**THE RESOURCES
OF THE
NEW ENGLAND-NEW YORK REGION**

HURRICANES

<u>Page</u>
SECTION XXXII - HURRICANES -	
INTRODUCTION -	1
Purpose. -	1
Scope. -	1
CHARACTERISTICS OF HURRICANES -	2
Definition. -	2
Origin. -	3
Hurricanes of the Western Hemisphere. -	5
Hurricane effects on large bodies of water. -	7
Hurricane effects on land. -	8
HISTORY OF HURRICANES -	9
HURRICANE OF SEPTEMBER 1938 -	17
General. -	17
Antecedent conditions. -	17
The Hurricane. -	18
Damages. -	19
Summary. -	24
HURRICANE OF SEPTEMBER 14-15, 1944 -	23
HURRICANES OF 1954 -	25
Hurricane Carol. -	25
Hurricane Edna. -	31
Hurricane Hazel. -	33
DAMAGES CAUSED BY 1954 HURRICANES -	35
General. -	35
Loss of life. -	36
Public property. -	37
Public buildings. -	38
Highways. -	38
Shore protective structures. -	39
Channel shoaling. -	40
Beach erosion. -	40
Works under construction. -	41
Estimates of damage. -	42
Shipping. -	42
Commercial vessels. -	44

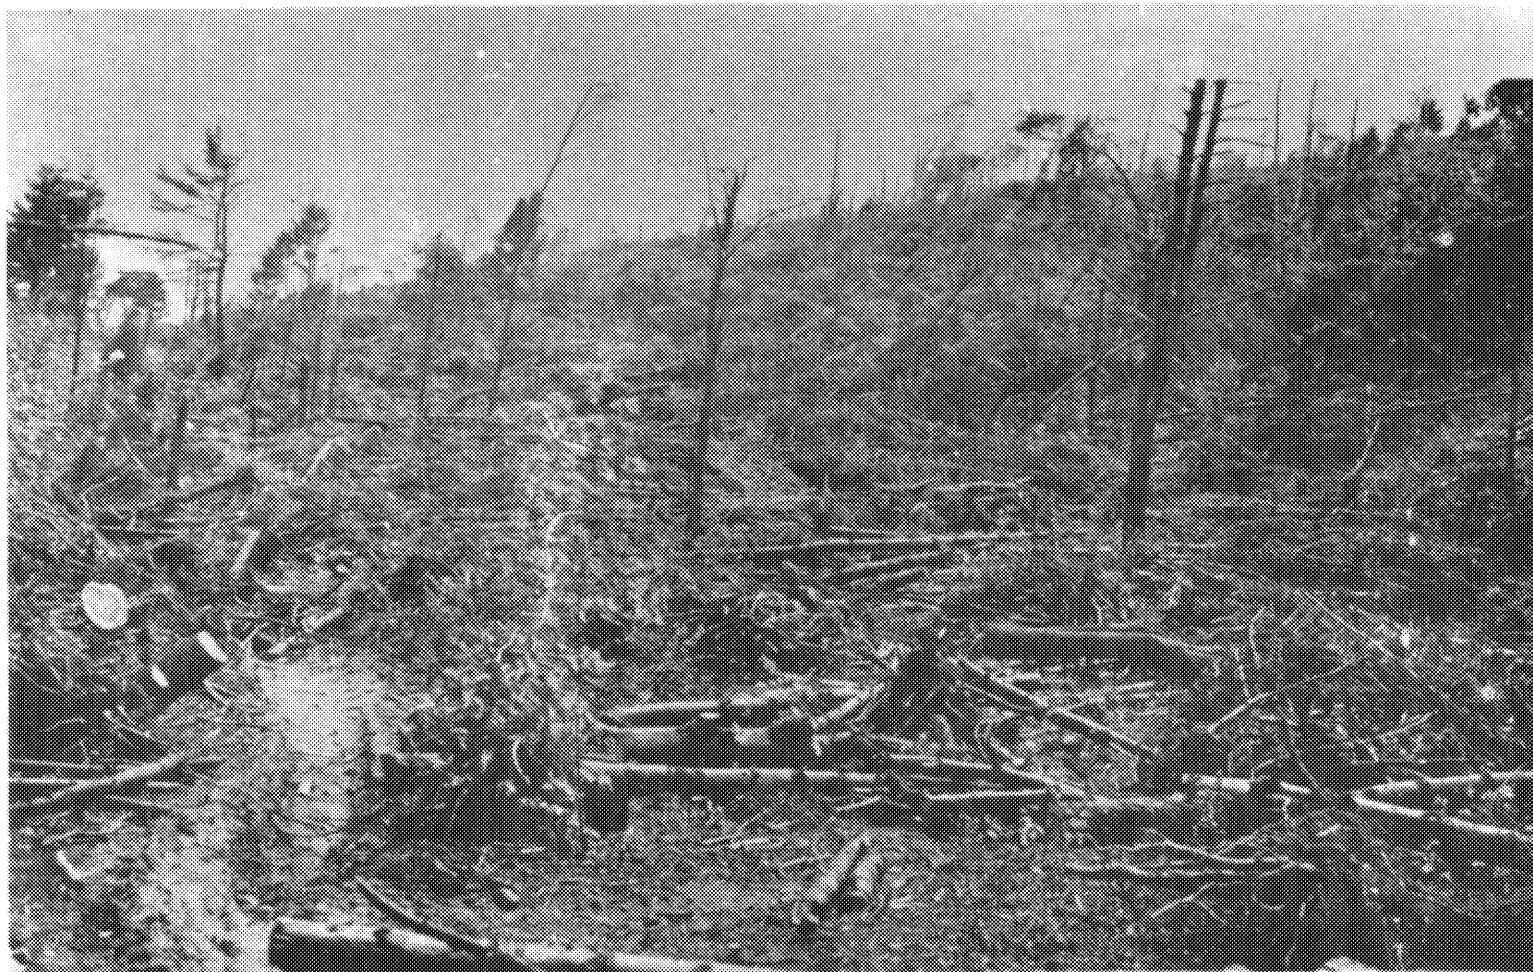
Timber damage. Near Keene, New Hampshire. Hurricane September 21, 1938.
New England-New York Region.

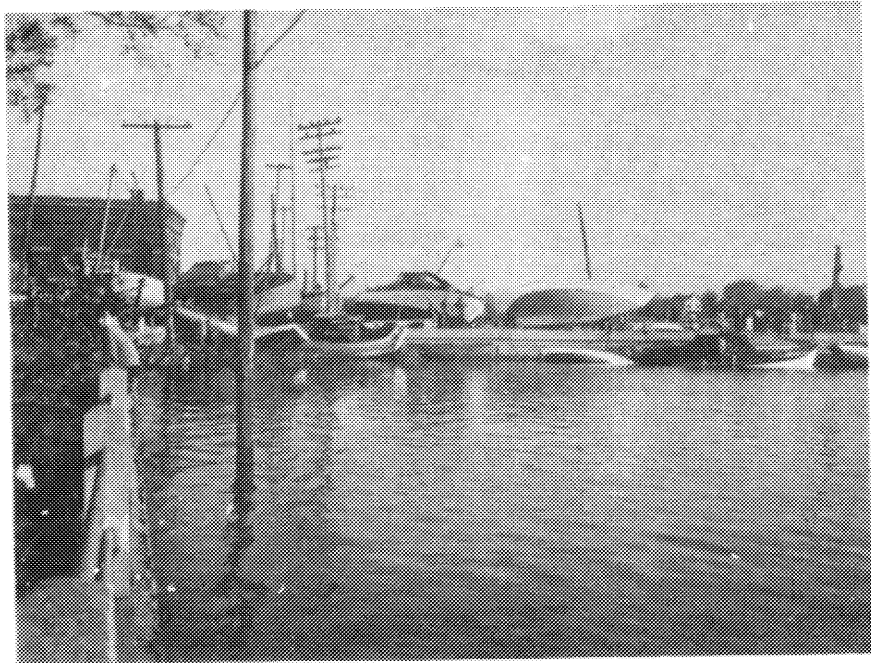
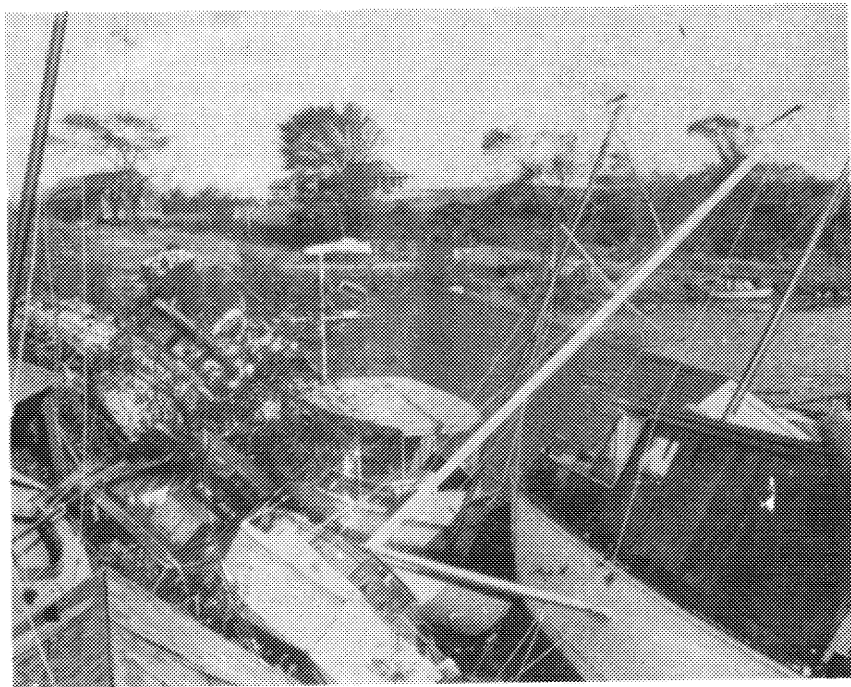
Small craft damage. Barrington (above) and Wakefield, Rhode Island. Hurricane September 21, 1938. New England-New York Region.

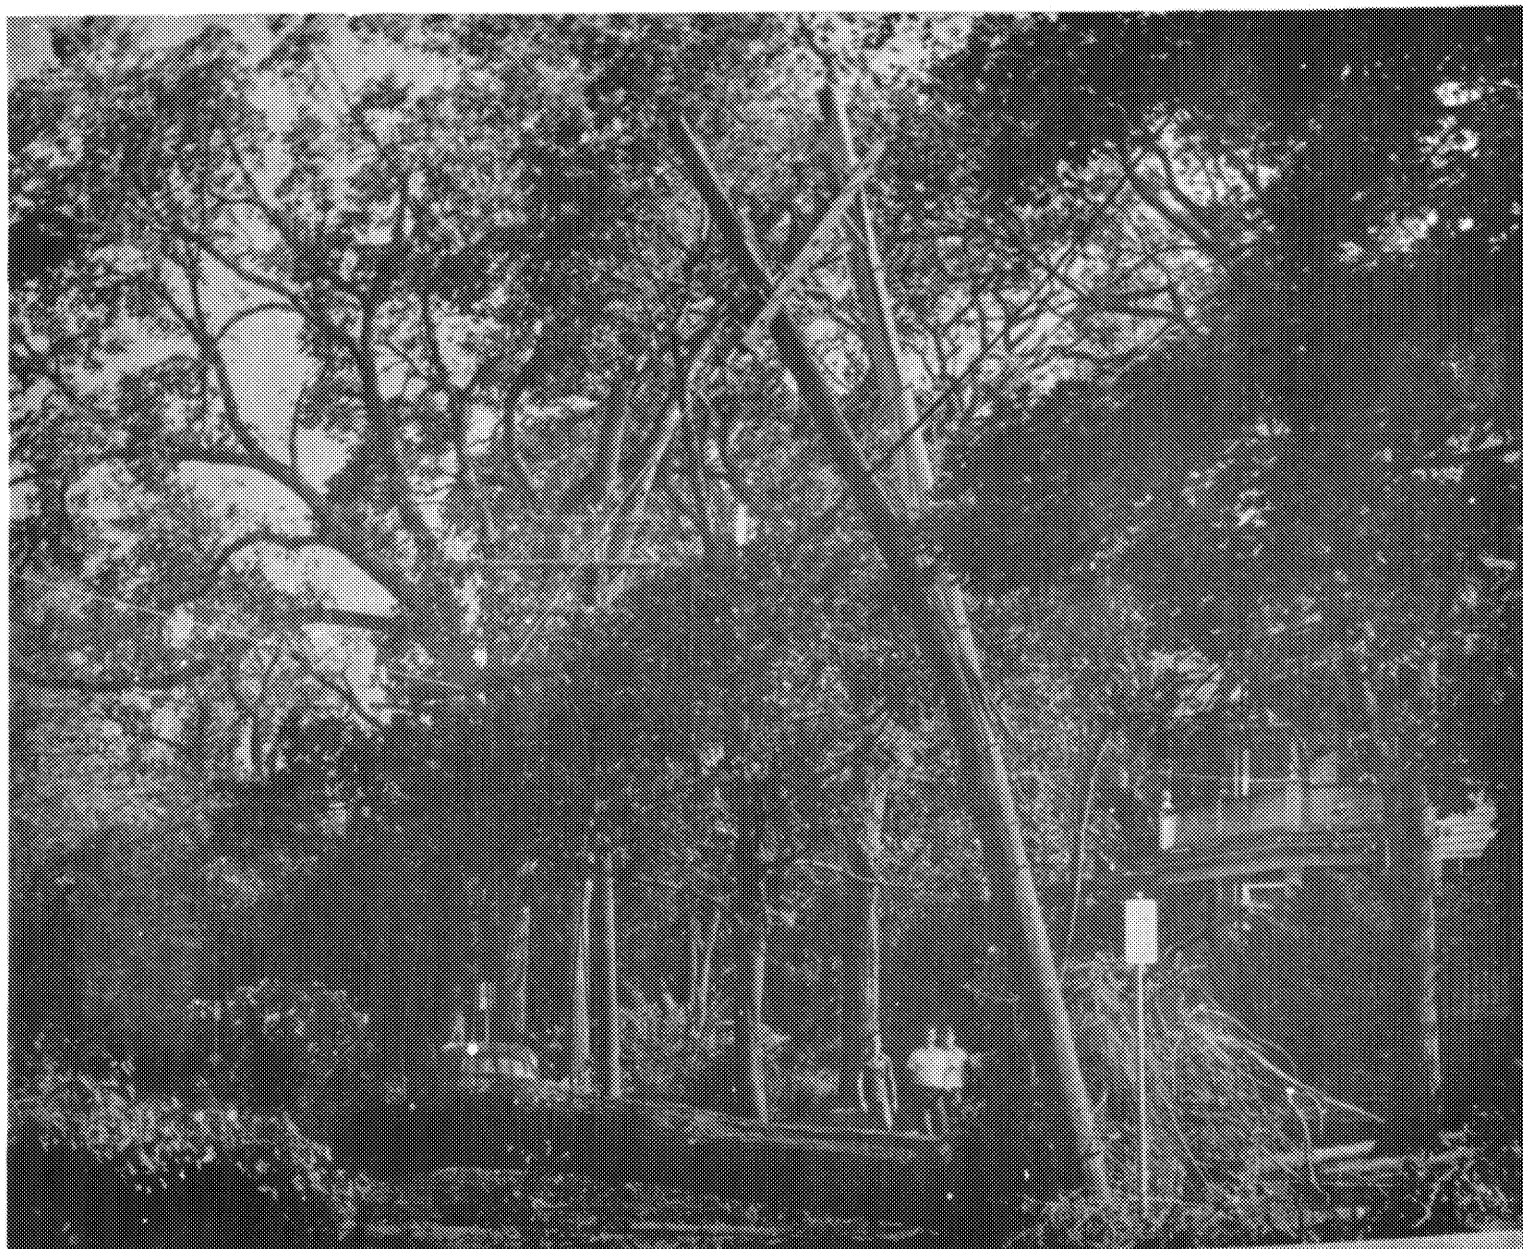
Wind damage. Utility service and use of street disrupted by fallen trees. Hurricane Carol. Quincy, Massachusetts. New England-New York Region.

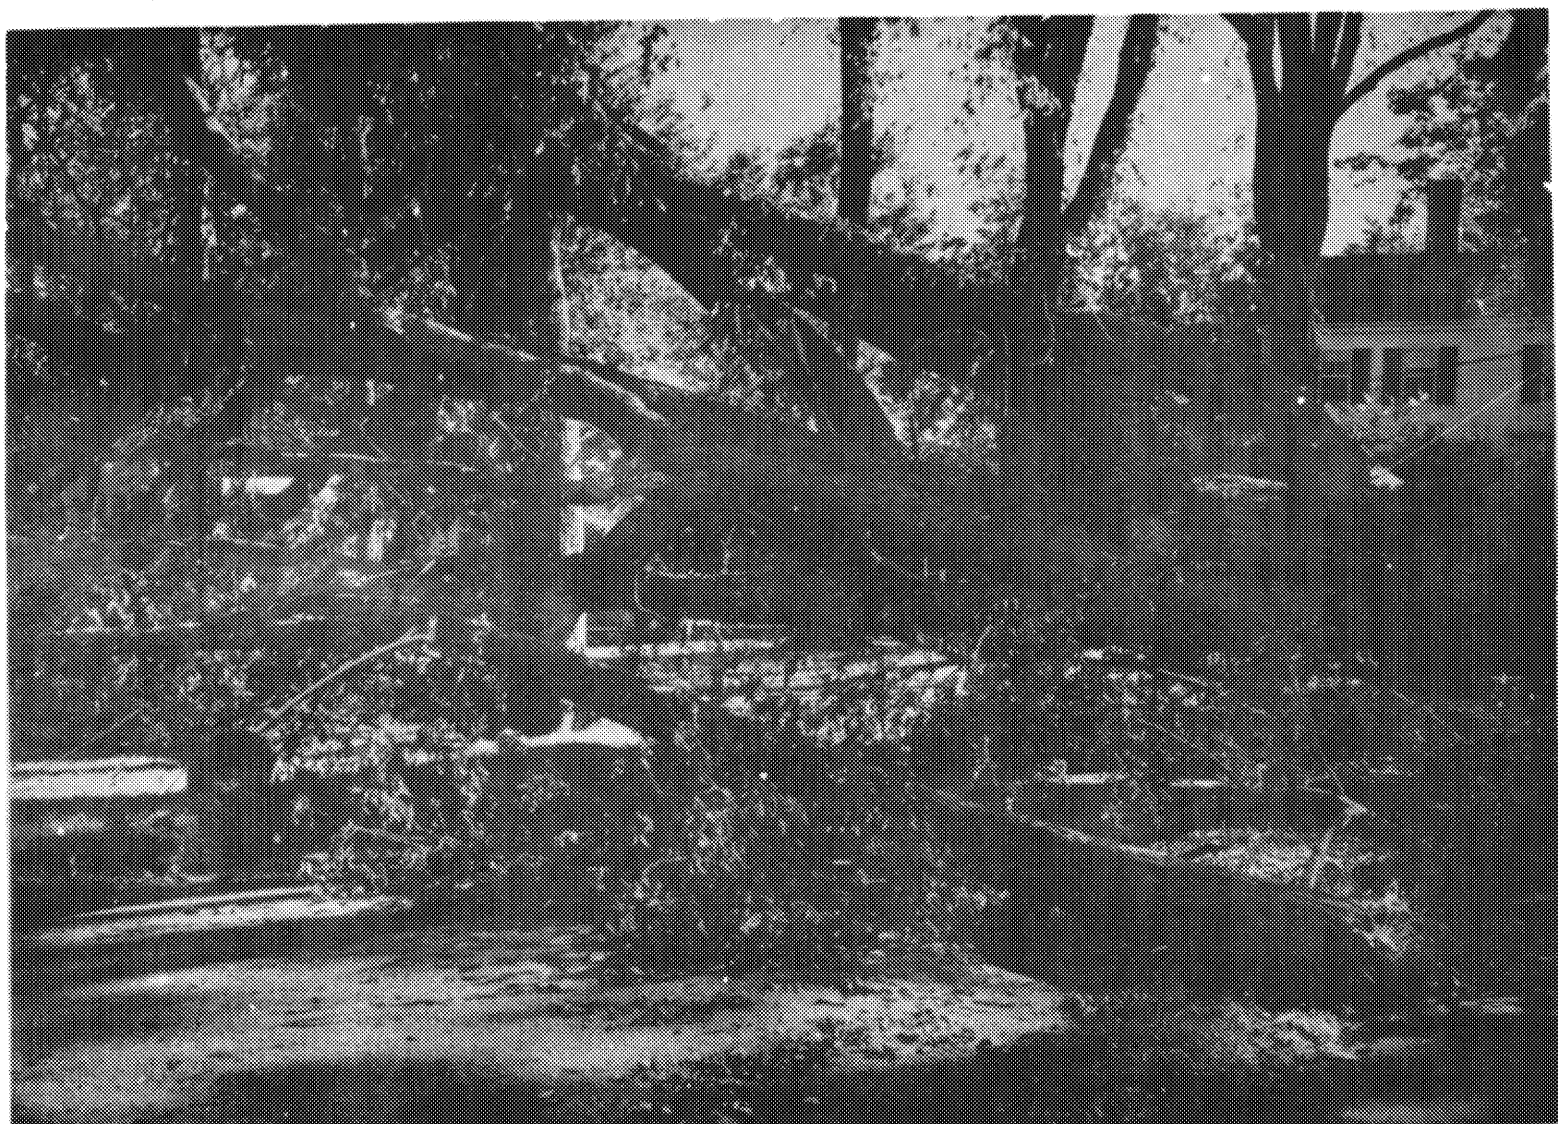
Wind damage. Trees and utility poles block street. Hurricane Edna. Castine, Maine.
New England-New York Region.

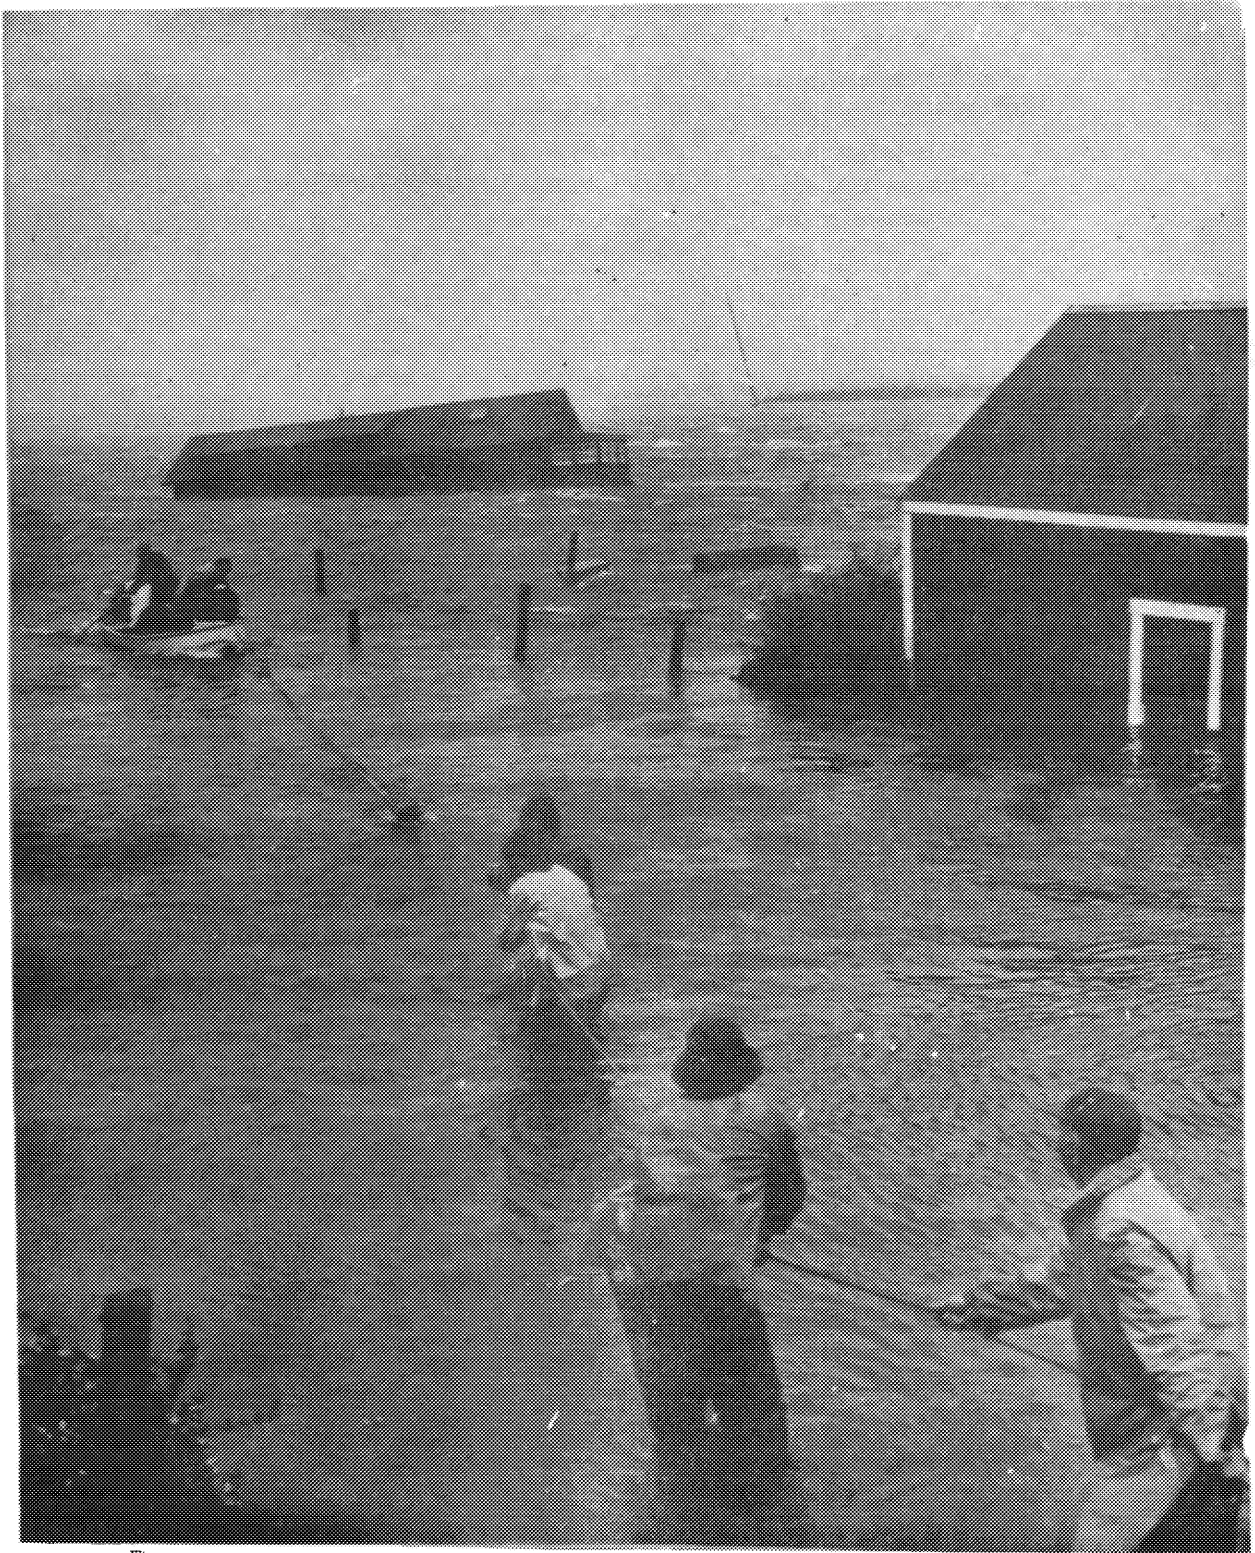
Rescue operation. Tidal flooding. Hurricane Carol. Westport Point, Massachusetts. New England-New York Region.

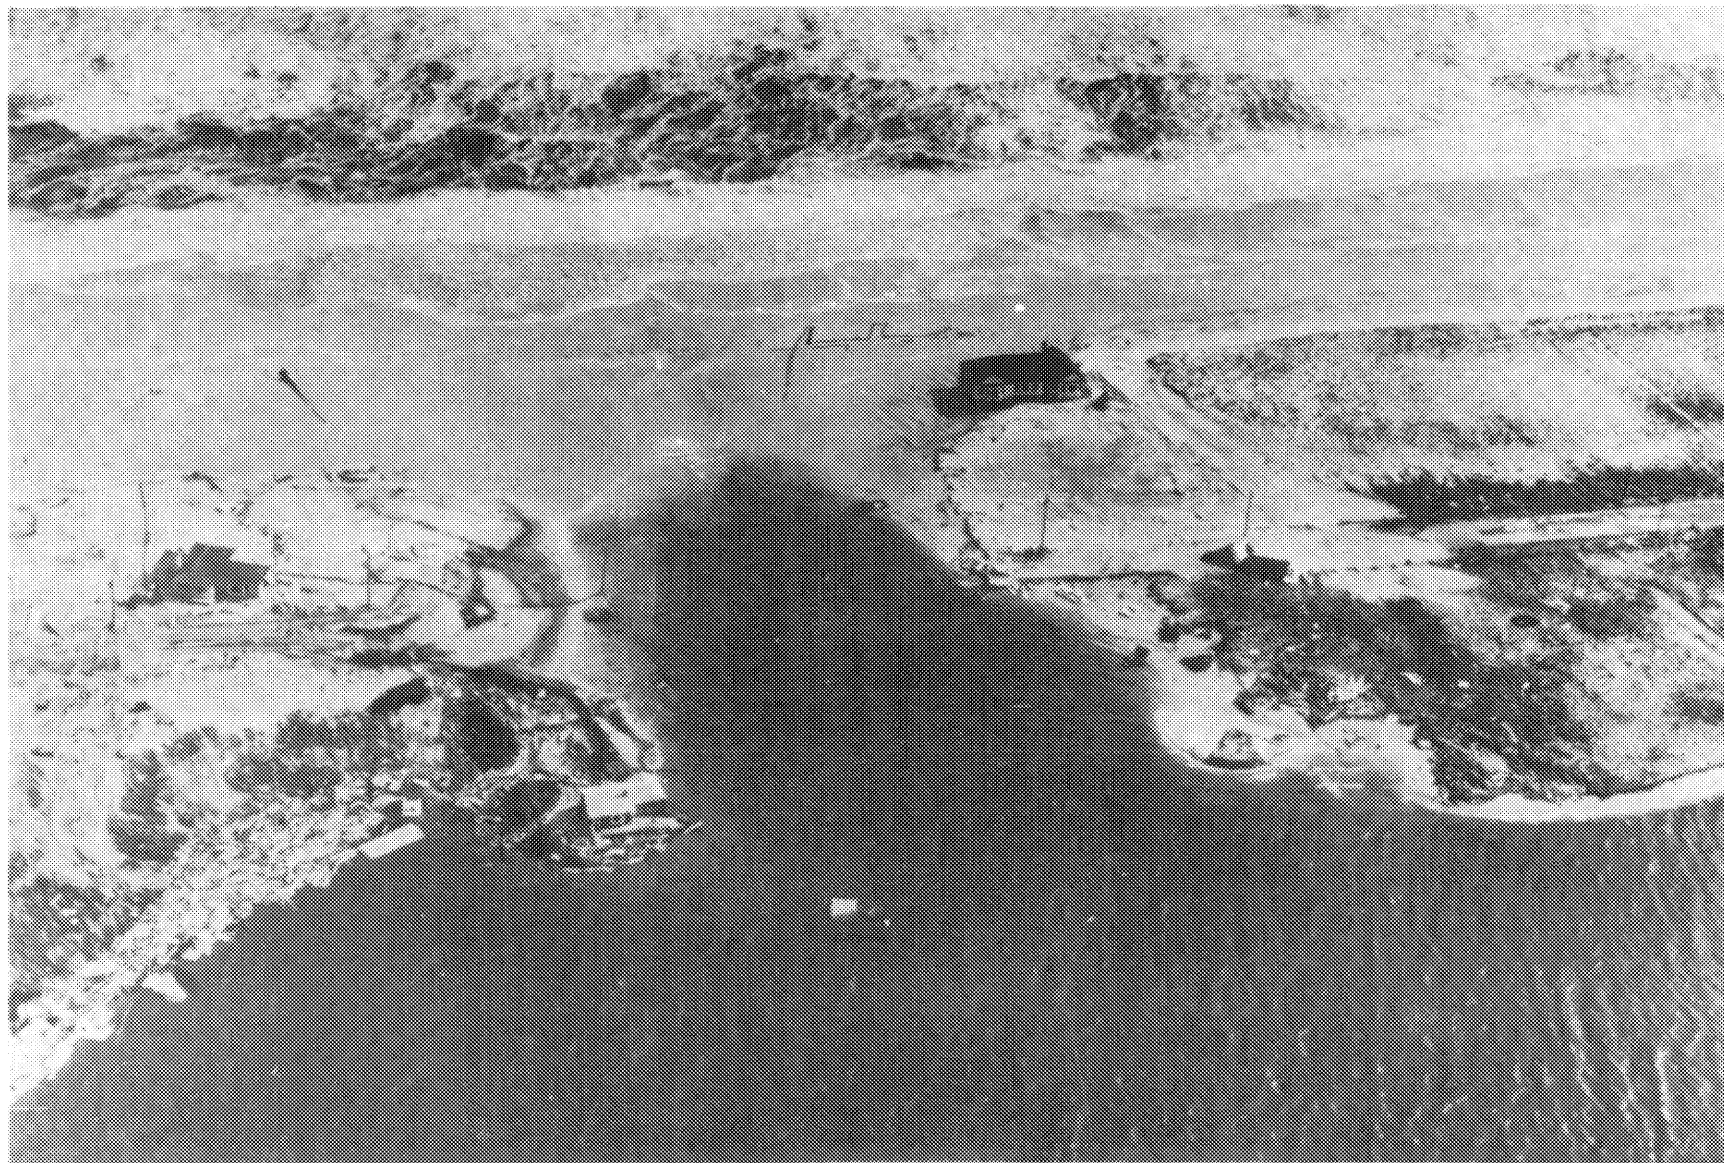
Beach damage. Breach in barrier beach. Hurricane Carol. Westhampton, L. I., New York.
New England-New York Region.

49. Beach erosion. - In some instances changes in the appearance of particular beaches resulting from Hurricane Carol were striking. Along the eastern portion of the south shore of Long Island, beaches were breached and large sections of dunes cut through. At Hammonasset Beach in Madison, Connecticut, the landward edge of the sand beach

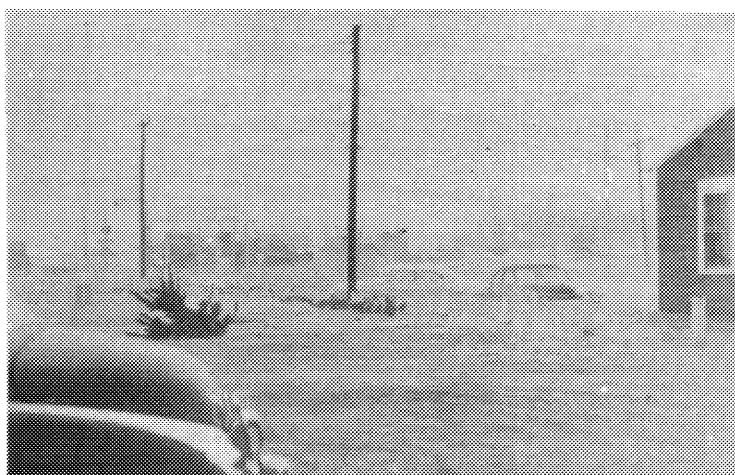
During: Boats riding at or above level of pier and autos awash.

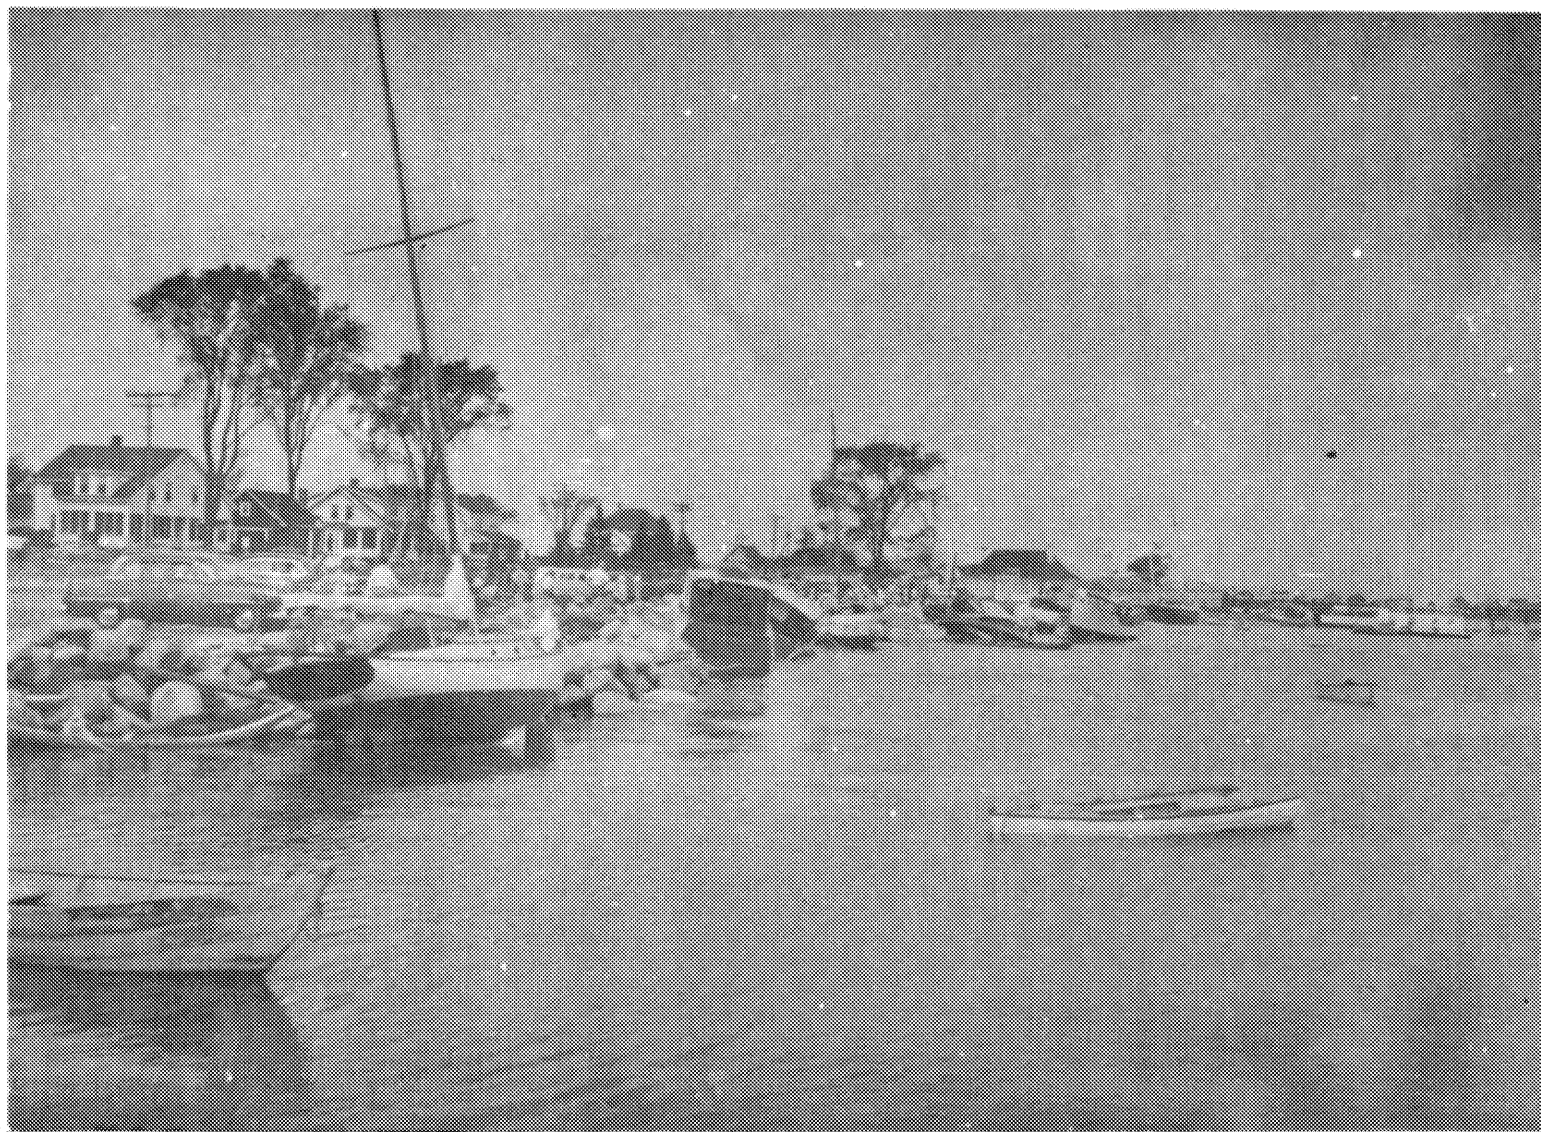
Damaged recreational craft. Scituate Harbor, Mass. Hurricane Carol.
New England-New York Region.

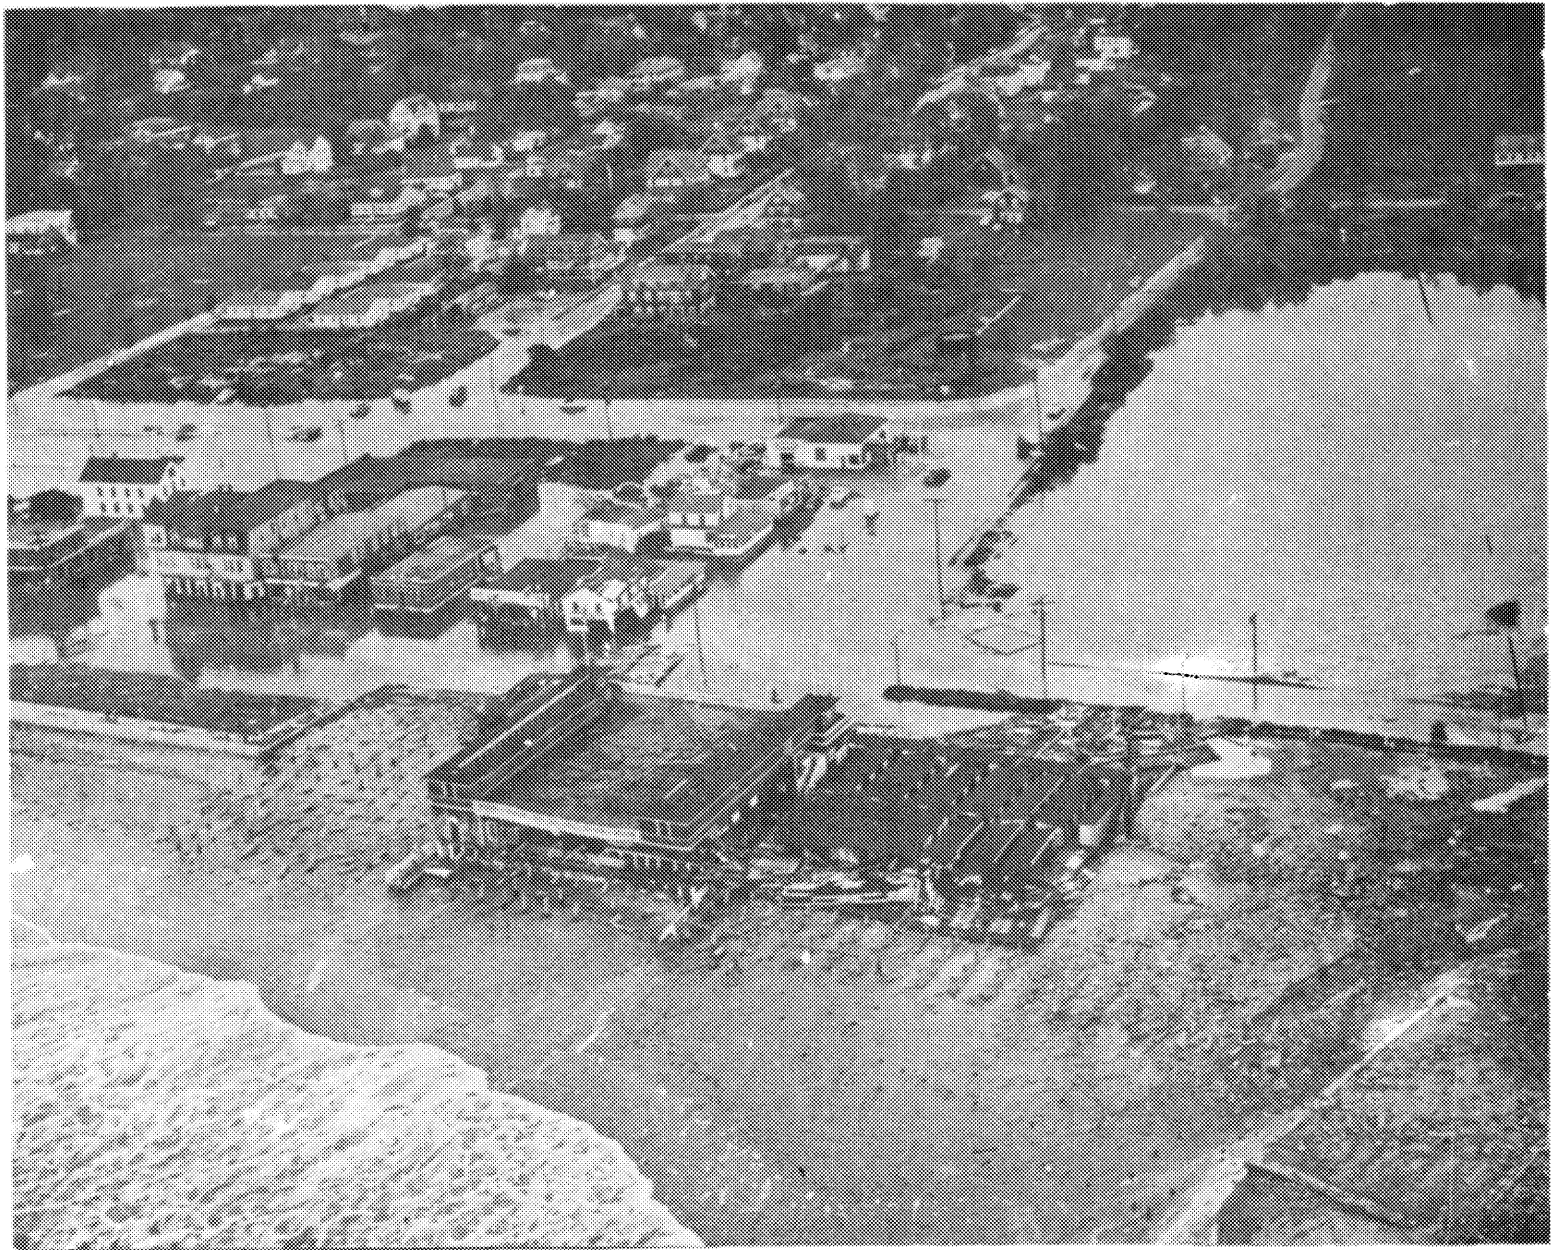
Waterfront property damage. Narragansett Pier, Narragansett, Rhode Island.
Hurricane Carol. New England-New York Region.

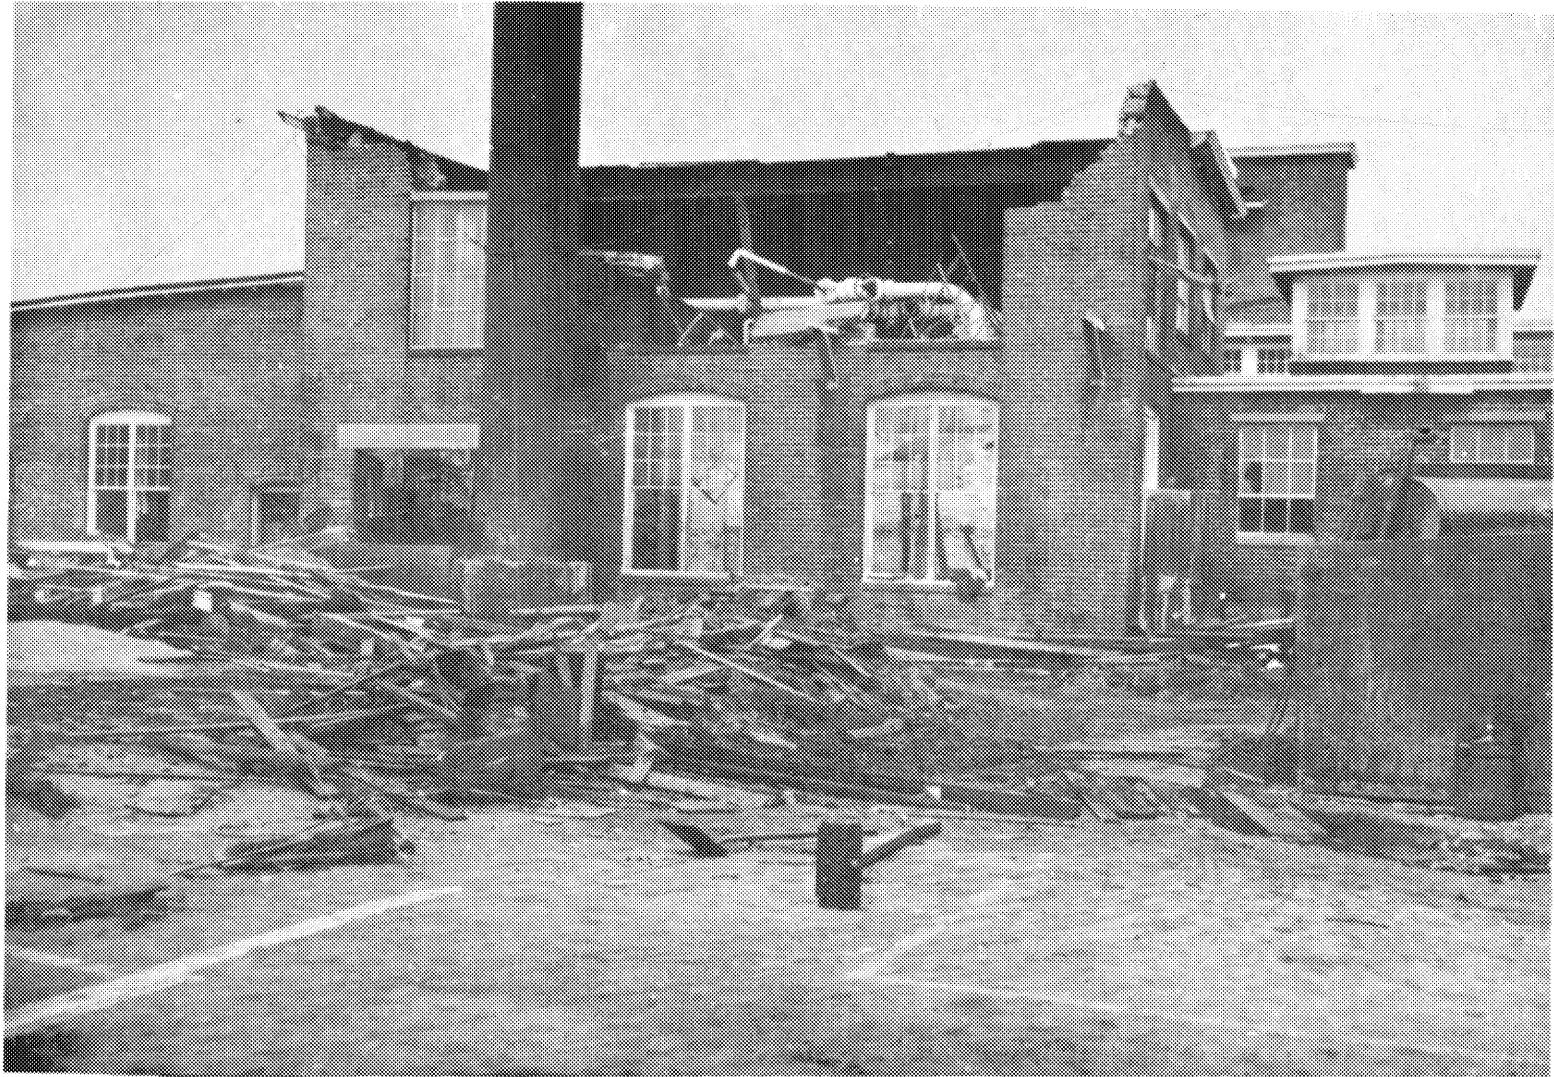
Industrial property damage. Hurricane Carol. New Bedford, Massachusetts.
New England-New York Region.

76. Seventy percent of the total industrial loss in coastal areas amounting to over \$27,000,000, occurred in the Providence, Rhode Island, and the New Bedford, Massachusetts areas. These

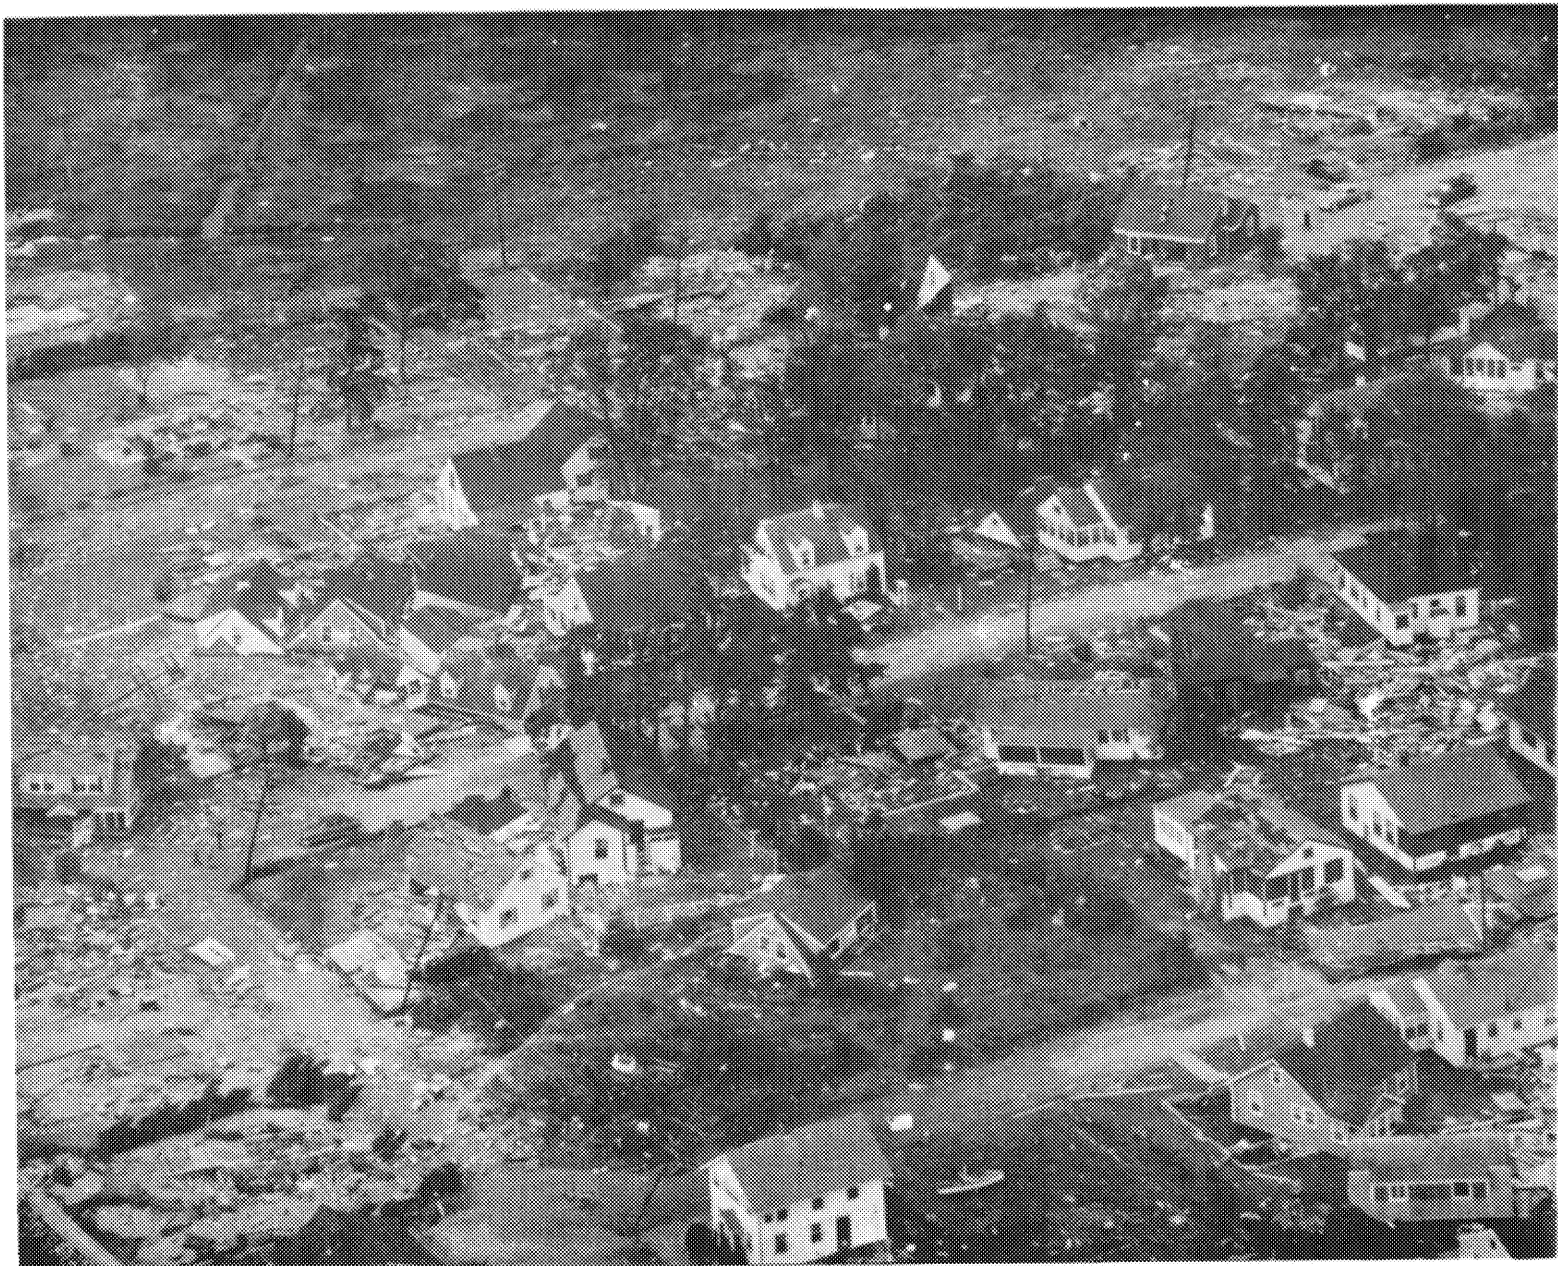
Residential property damage. Wareham, Massachusetts. Hurricane Carol.
New England-New York Region.

97. The destruction of homes in Hurricane Carol was staggering. Uncounted cottages and other structures were demolished by the accompanying flood with only piles of rubble left. Cottages nearest

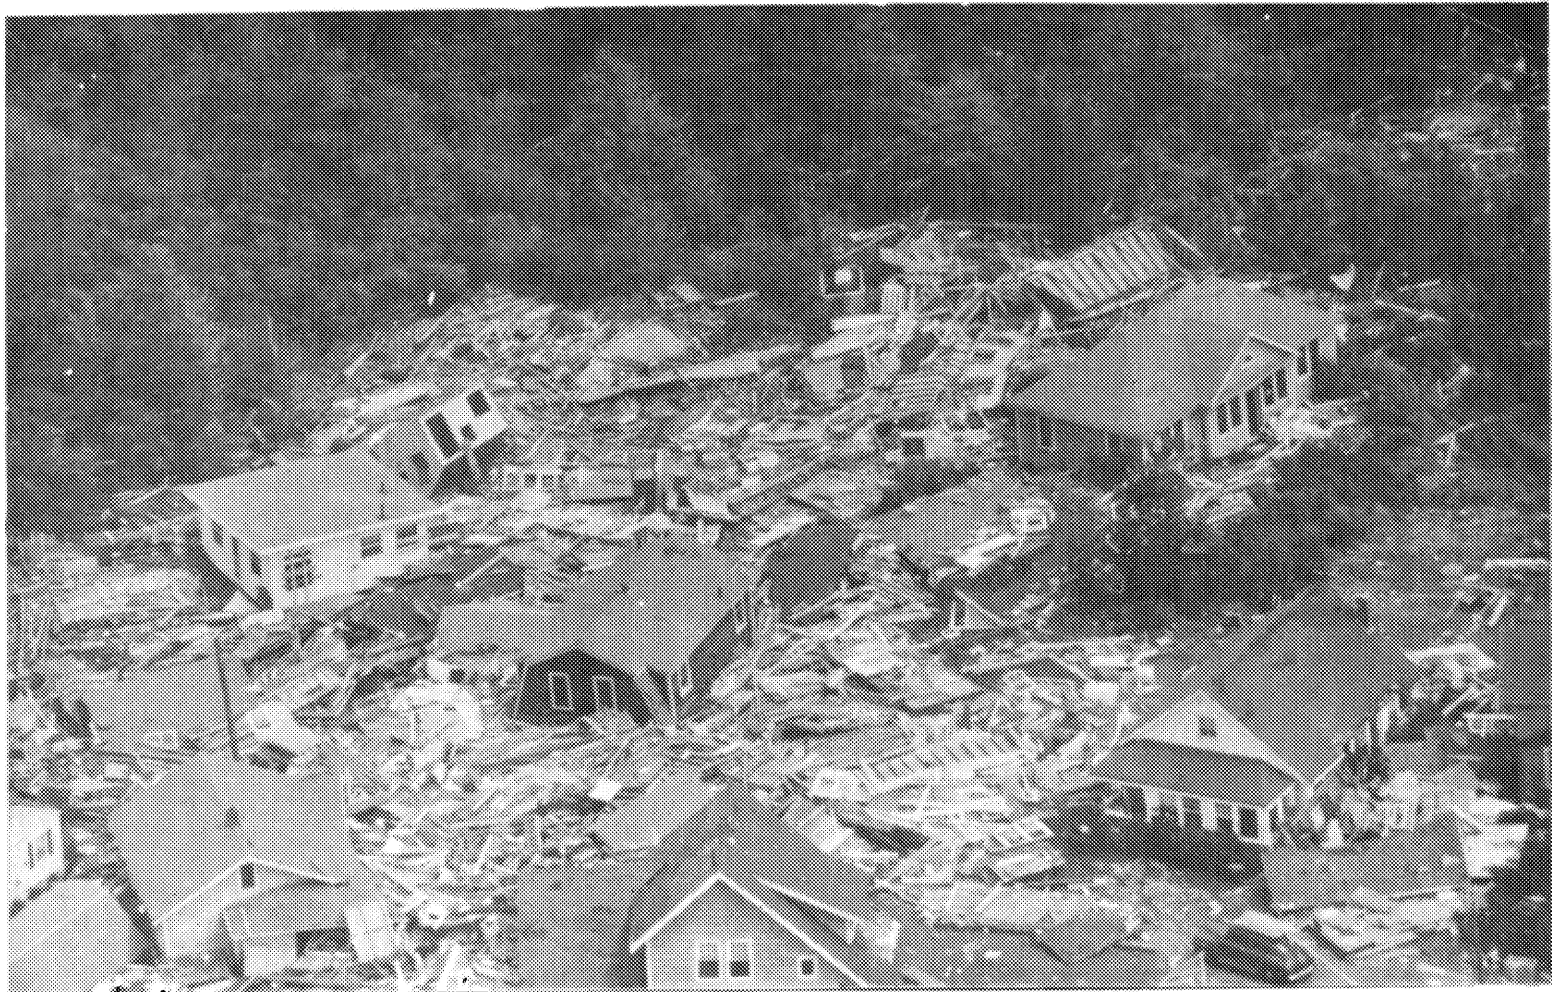
Private property damage. Crescent Beach, Mattapoisett, Massachusetts. Hurricane Carol.
New England-New York Region.

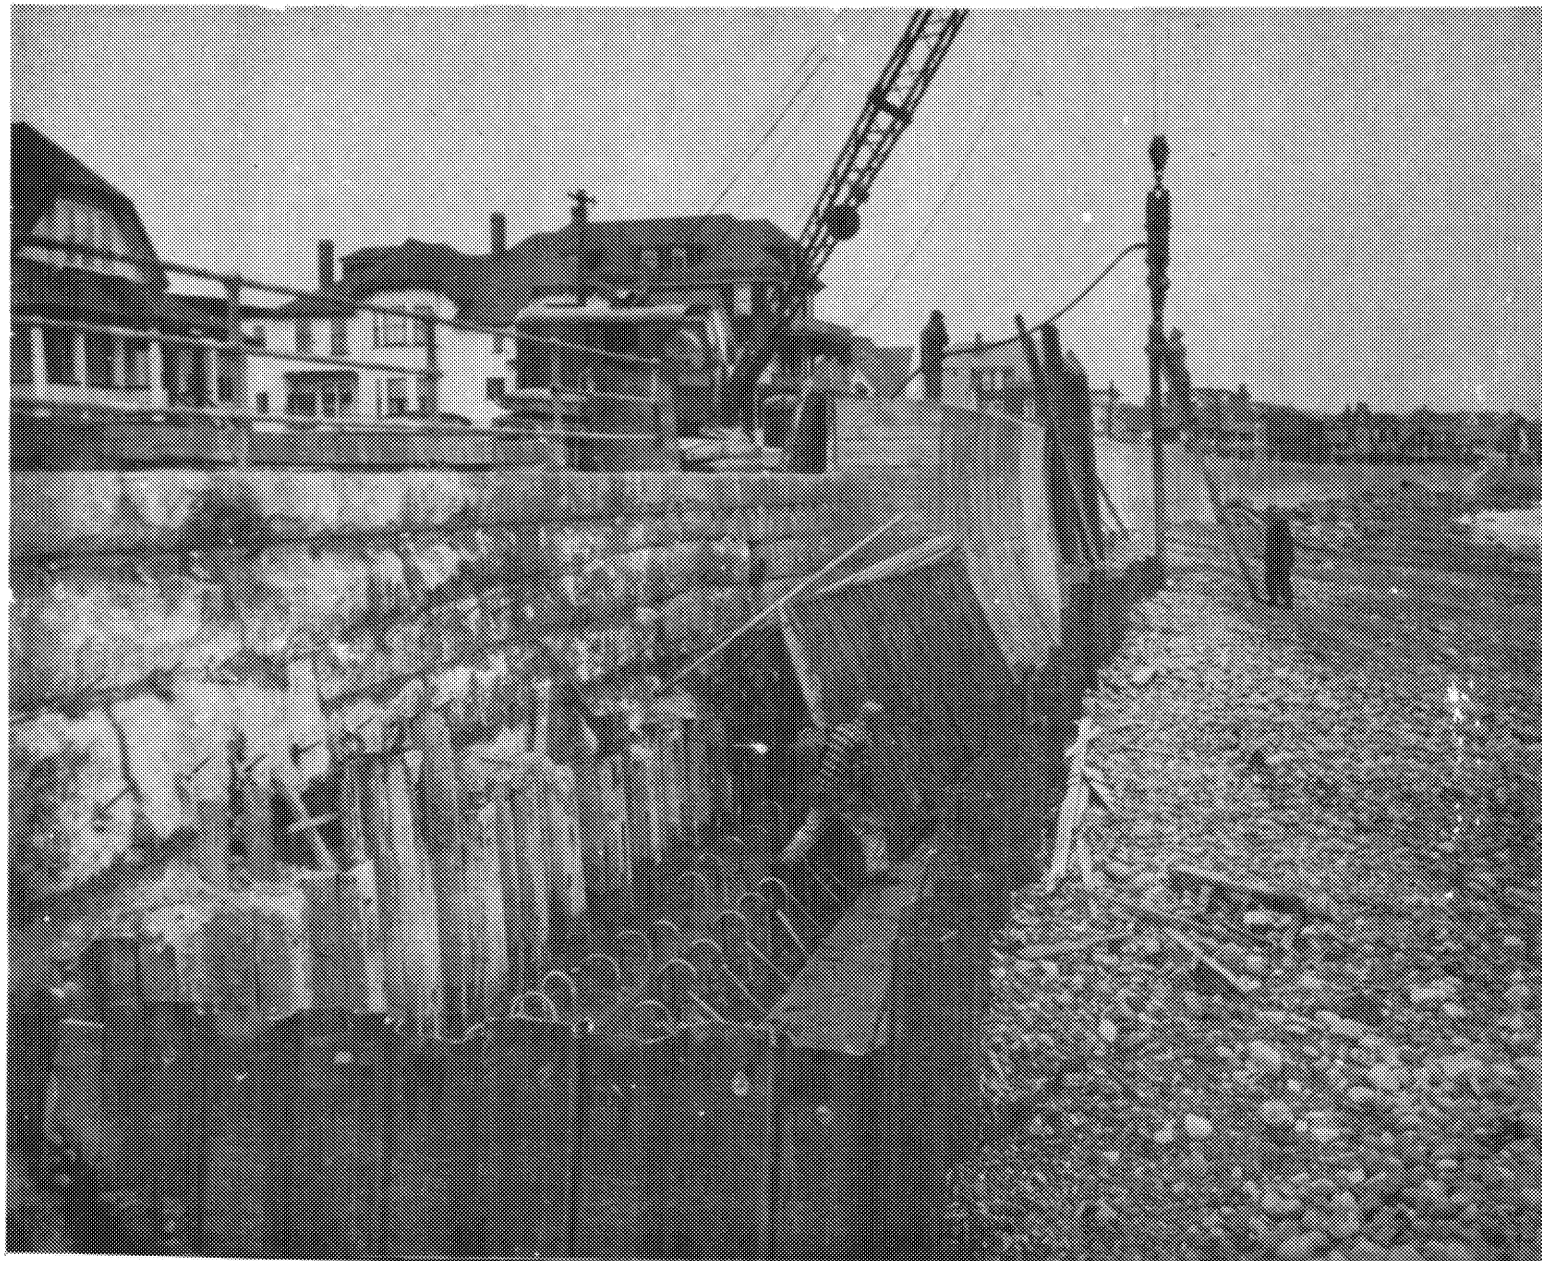
Seawall. Winthrop, Massachusetts. New England-New York Region.

(3) The costs of seawall construction are relatively high, especially if they are to be built with strength to withstand
